Minivan Door Auto-close

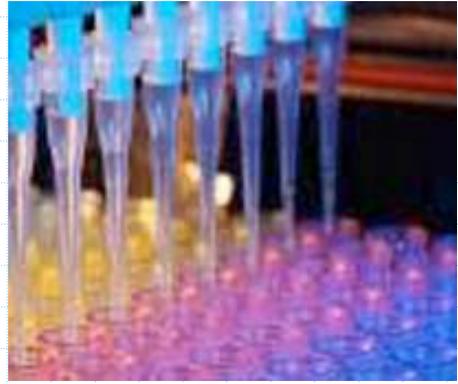
Biological Assay Performance Variation

A manufacturer of healthcare products was concerned with performance of microtitre plates. These have an array of wells in which sample reactions are assayed by passing high-intensity light to the wells. The light colour emitted by the reaction happening in each well is quantified by a detector.

An Isolation Strategy was employed – splitting between inputs to the process and the functions of the process. Tactically, this only involved the same number of plates as a regular production test sample, and was completed in a couple of hours. The causal mechanism lived in the first drying operation, not coating or washing. Over-aggressive air flow drying caused the variation.
